THE HEXAGON (Ephraim Shay House) Harbor Springs, Michigan

Tech Notes

NUMBER 3

In-Kind Replacement of Historic Stamped Metal Exterior Siding

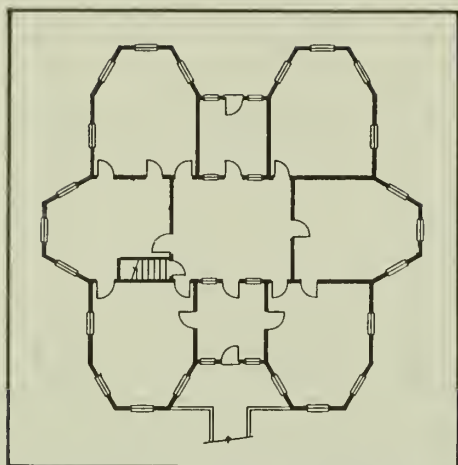
1. Windows in each elevation of the hexagonal wings offer views in every direction from the center of the house. This first floor plan of the Hexagon shows the new, post-rehabilitation uses. Drawing: Jeffrey Pascale, from plans by Richard Hiler.

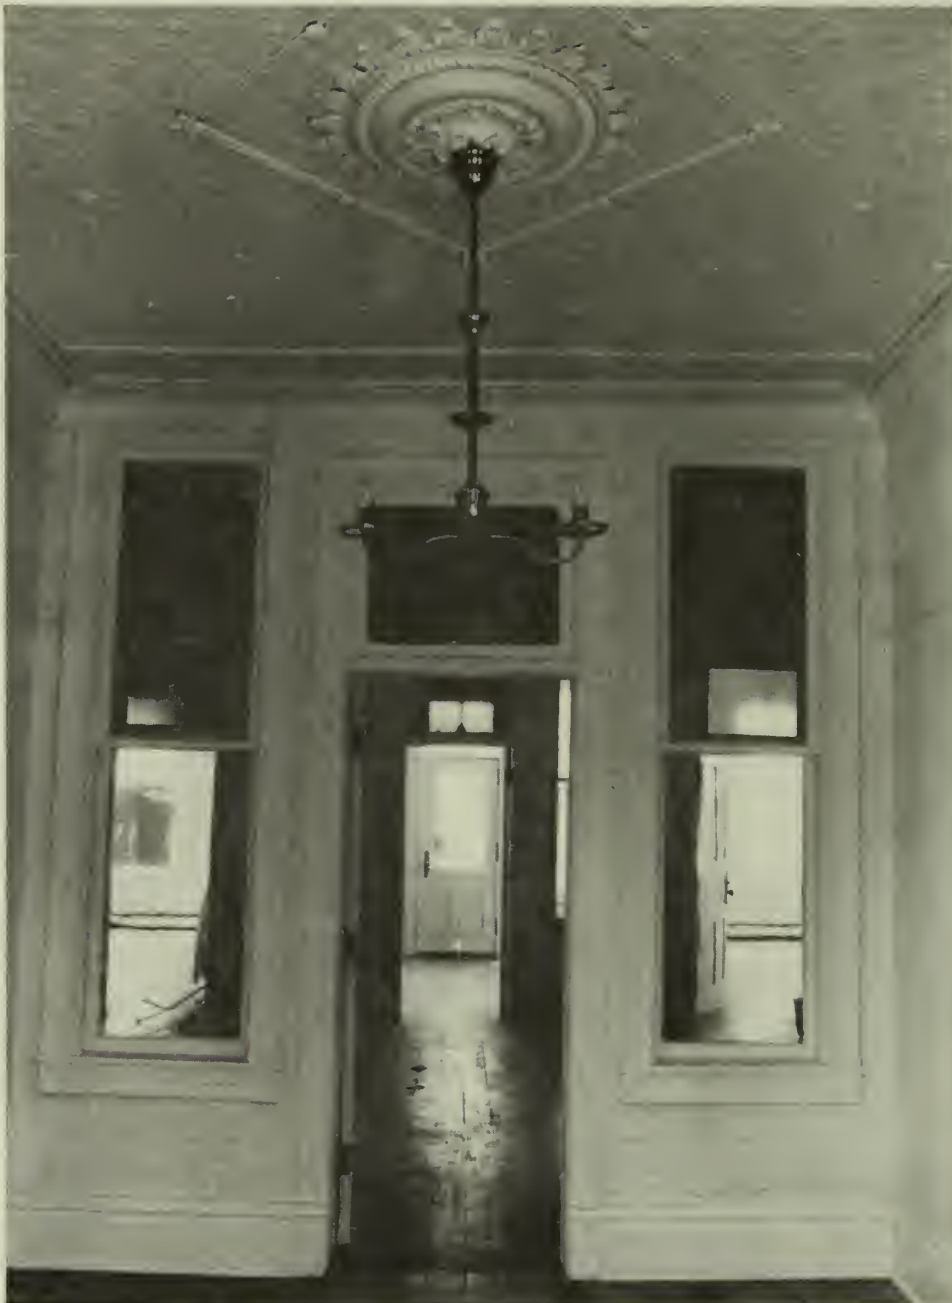
In contrast to the exterior metal siding, the interior stamped ceilings and walls remained in good condition. All of the interior metal was retained, with only isolated areas requiring patching due to minor rust. In addition, the exterior window hoods had not deteriorated like the siding and only routine repairs were necessary for their retention.

2. The walls and ceilings of each interior room are sheathed with stamped metal siding in a variety of decorative patterns. Photo: Brian Conway.

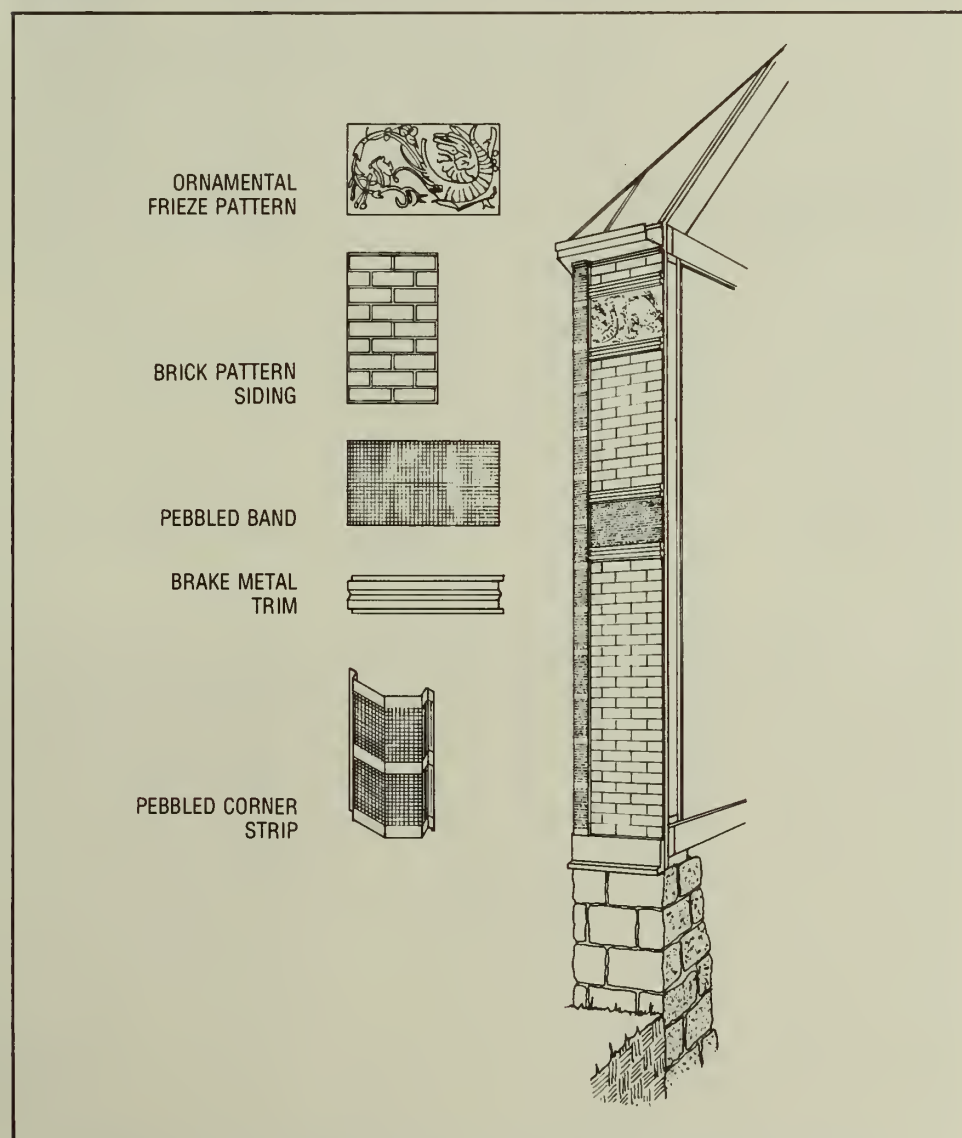
Five exterior sheet metal patterns required replacement: the brick pattern that covered more than half of the exterior, two ornamental band patterns, the wall corner pattern, and the molding that separated the ornamental bands from the brick pattern (see figure 5).

5. Five different sheet metal patterns were used to cover the exterior wall. Drawing: Timothy Buehner.
